Problem:  
Door sashes do not close properly

Problem:  
water tracks along the Aluminium track on the inside

NatureLine/DesignLine Lift slide door

Troubleshooting guide

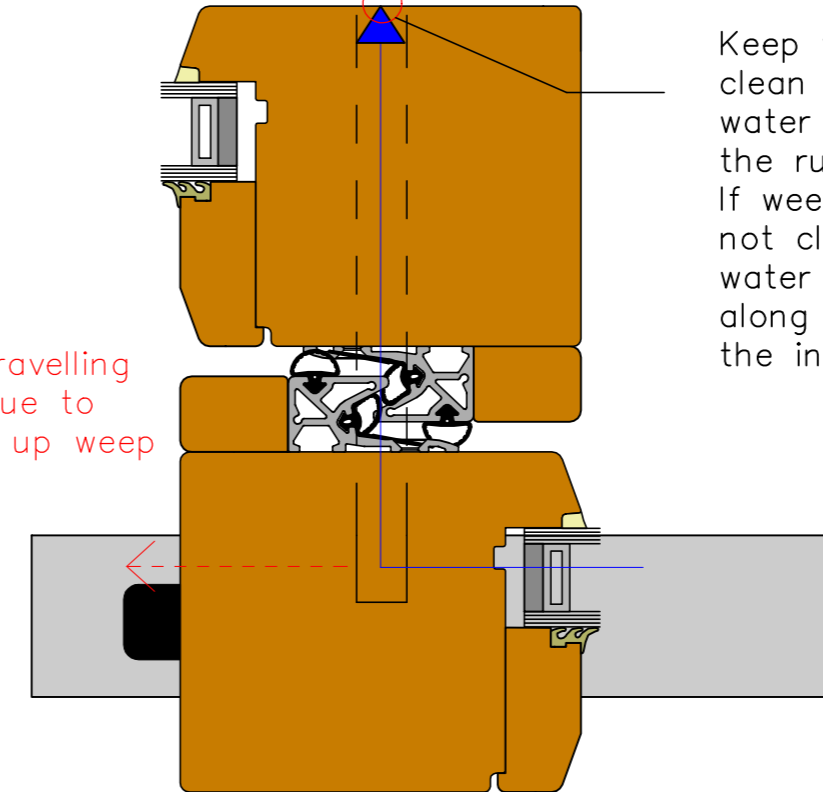
Section C2 (Design C)

Water travelling inside due to clogged up weep holes!

Keep weep holes clean in case water travels along the running track. If weep holes are not clean the water could travel along the track to the inside!

- Notes:
- It is normal in the building process that shavings or dust can end up in the weep holes. Blow the weep holes out with compressed air or use a drill in case the dust is compacted.

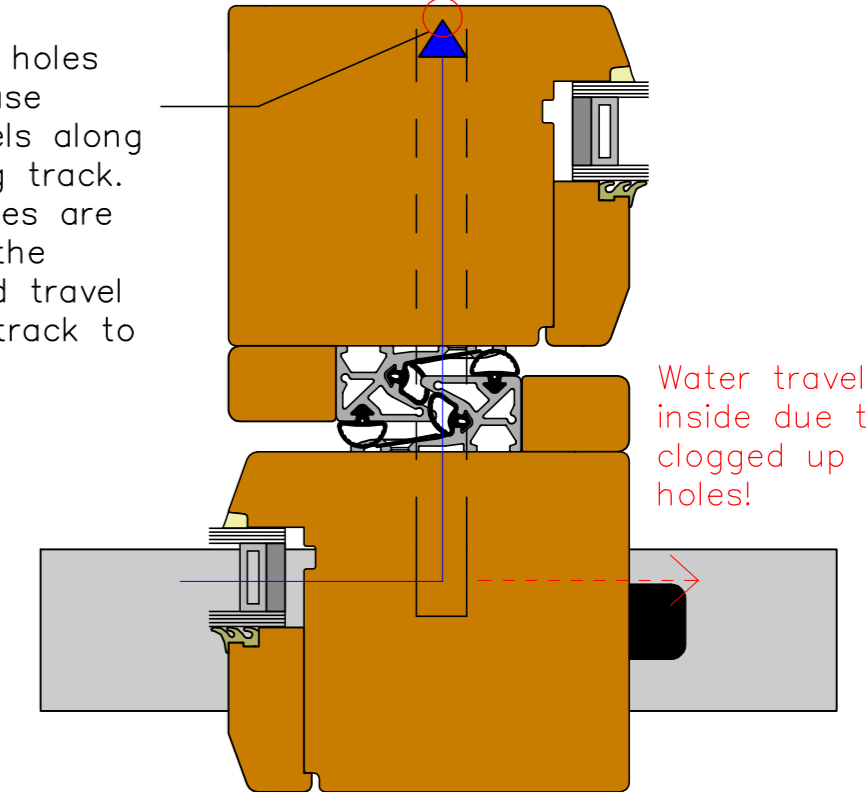
Section A2 (Design A)

Water travelling inside due to clogged up weep holes!
